Frequently Asked Questions

XML load error

#5400-0387 Version 1.0.1.1

TOSHIBA TELI CORPORATION

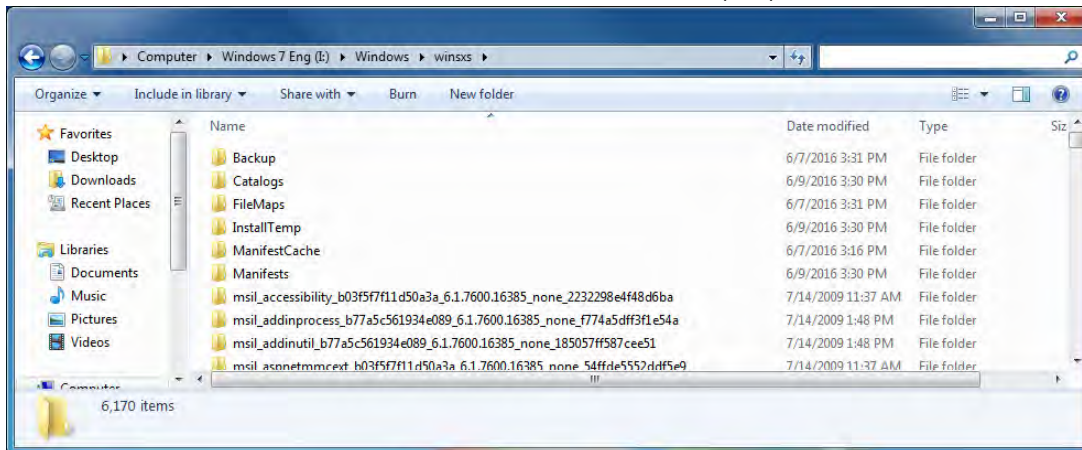
- A. Open “winsxs” (windows side by side) folder under “Windows” folder with Explorer. Path of “winsxs” folder is typically “C:\Windows\winsxs”.

This folder contains various versions of shared assemblies (dlls).

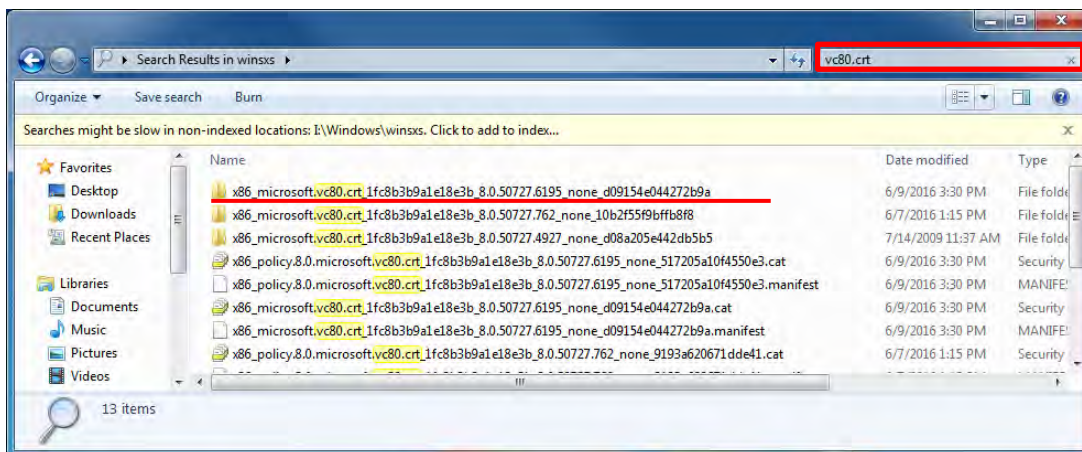
- B. Search “vc80.crt” using search feature of Explorer. “vc80.crt” is name of VC++2005 Redistributable runtime library.

- C. Check the retrieved libraries

Items that has folder icon

are folders that contains dlls, items that has icon

are catalog file, items that has icon

are manifest file.

x86_microsoft.vc80.crt_1fc8b3b9a1e18e3b_8.0.50727.6195 none_do9154e044272b9a
 CPU type DLL package name DLL package ID Version ID

“amd64” will be shown in CPU type area if the folder contains x64 dlls.

Version ID of vc80.crt installed with “VC++ 2005 SP1 Redistributable MFC Security Update (KB2538242)” is **6195**.

If “VC++ 2005 SP1 Redistributable MFC Security Update (KB2538242)” is already installed, 6195 version vc80.crt folder exists under winsxs folder.

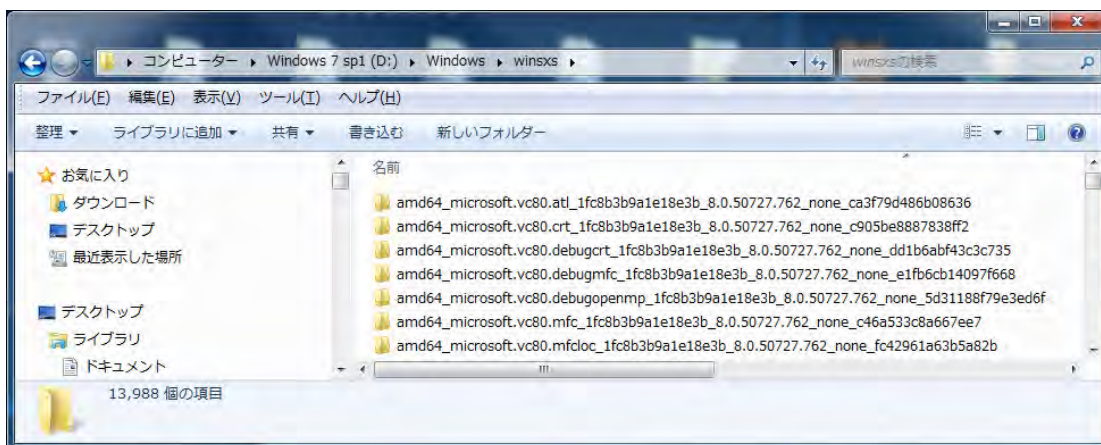
- A. Windows フォルダ下の winsxs フォルダ (windows side by side) を Explorer で開く。
winsxs フォルダのパスは通常 C:\Windows\winsxs です。
このフォルダはさまざまなバージョンの共有 dll を管理する dll です。

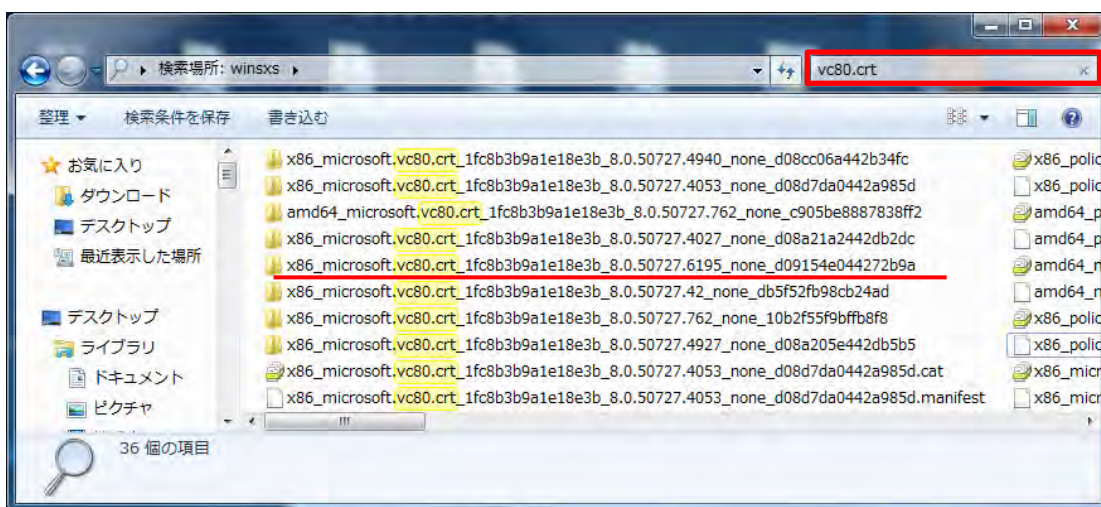
- B. Explore 画面のサーチ機能で”vc80.crt”を検索する。
”vc80.crt” は VC++2005 再頒布可能パッケージのライブラリ名称です。

- C. 検索結果を確認する。

共有 dll が保存されているフォルダには 📁 アイコン、カタログファイルには 📄 アイコン、マニフェストファイルには 📄 アイコンが表示されます。
